# R&S®OSP 220/230/320 Open Switch and Control Platform

## Release Notes

### Firmware Version 2.00.033

1528.5295.00 | Version 06 | R&S®OSP 220/230/320 Open Switch and Control Platform

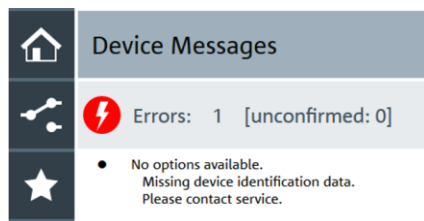
Previous firmware versions can lead to errors in reading device data:

License management is deactivate and license options like OSP-K100 are not installable.

Recommend update of all previous firmware to version 2.00

The error can only fixed by the Rohde & Schwarz customer support
