R&S® CLG

Cable Load Generator

Release Notes

Firmware Version 01.09

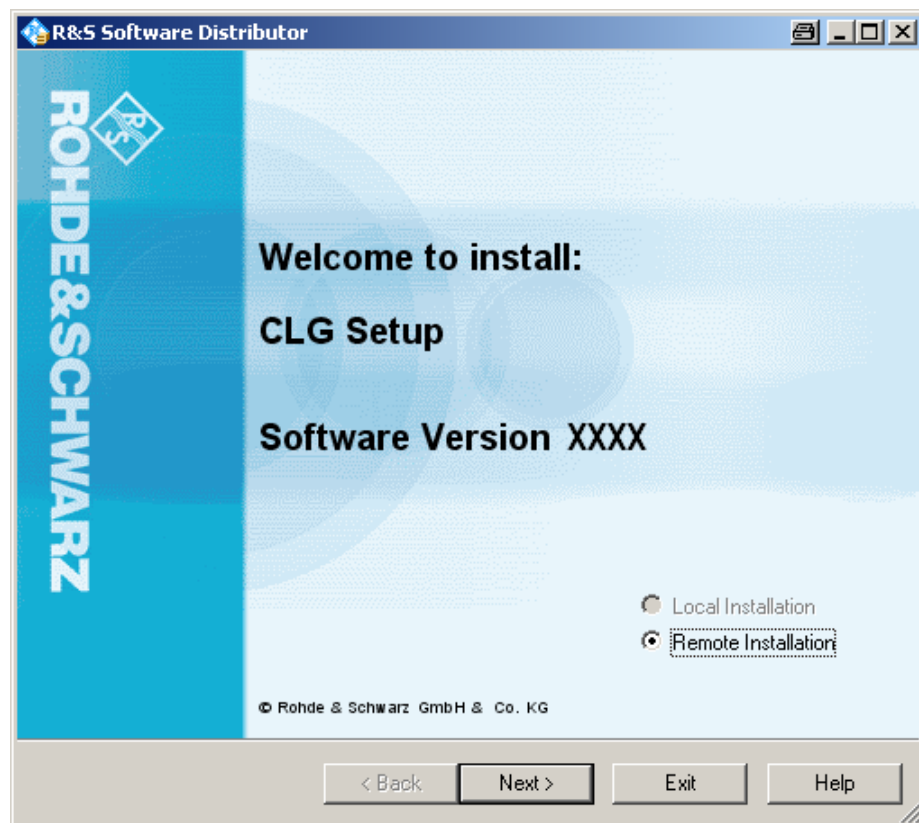
1. Make sure that the computer and the R&S CLG are connected by LAN.
2. Switch on the R&S CLG.
3. Wait until the R&S CLG firmware has booted and the application has started.
4. On the computer, execute *CLG_Setup_FW_xxxx.exe*.
The "R&S Software Distributor" is displayed. Only "Remote Installation" is available.
