# Release Note

R&S® IQR20  
R&S® IQR100

**Firmware Version 4.10.05**

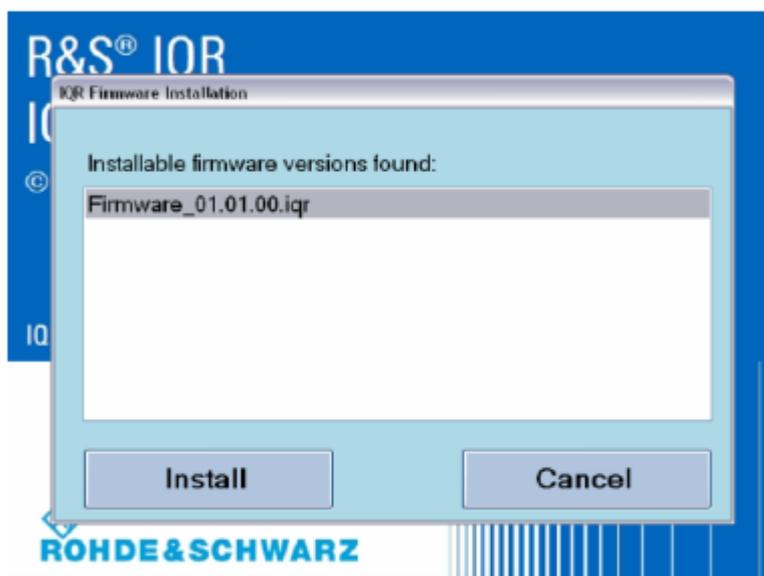
figure 1 : IQR firmware installation

1. Download a firmware file with the extension \*.IQR on your computer and copy it to a USB stick.
2. Power down the R&S IQR.
3. Insert the stick into any of the master USB connectors on the front or rear panel of the R&S IQR.
4. Power up the R&S IQR again and wait for the firmware selection dialog.

5. **Firmware selection:** if there is only one firmware file on your memory stick, it will be shown already highlighted in the list. If there are multiple firmware files on your USB stick or if you have connected more than one USB stick containing firmware files, all different firmware versions will be shown in the list. Select the firmware you want to install.

6. Tap "Install" to continue the update process. Otherwise tap "Cancel" to quit the update and launch the currently installed firmware version.
7. A warning will appear to prevent you from losing your own device settings. If you have already saved your configuration or if you want to return to default values, tap "Install" to proceed to the firmware update. Otherwise tap "Cancel" to quit the update and launch the currently installed firmware version.

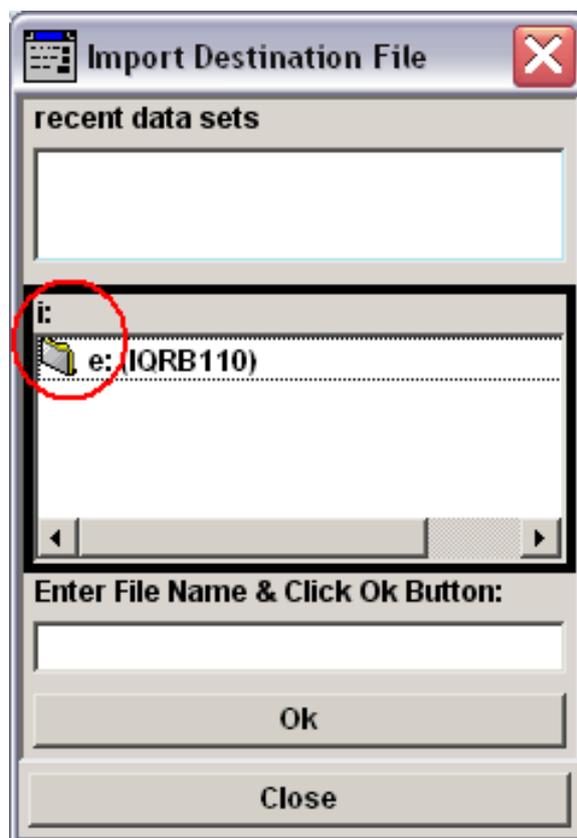
figure 2 : file select dialog

Take care on the drive letters. Occasionally, the initial drive letter is wrong in the file selection dialog box. You might see for example the following import destination file dialog.

If you would enter a file name now and confirm entry with ENTER key, the file would be written to drive i: instead of drive e:

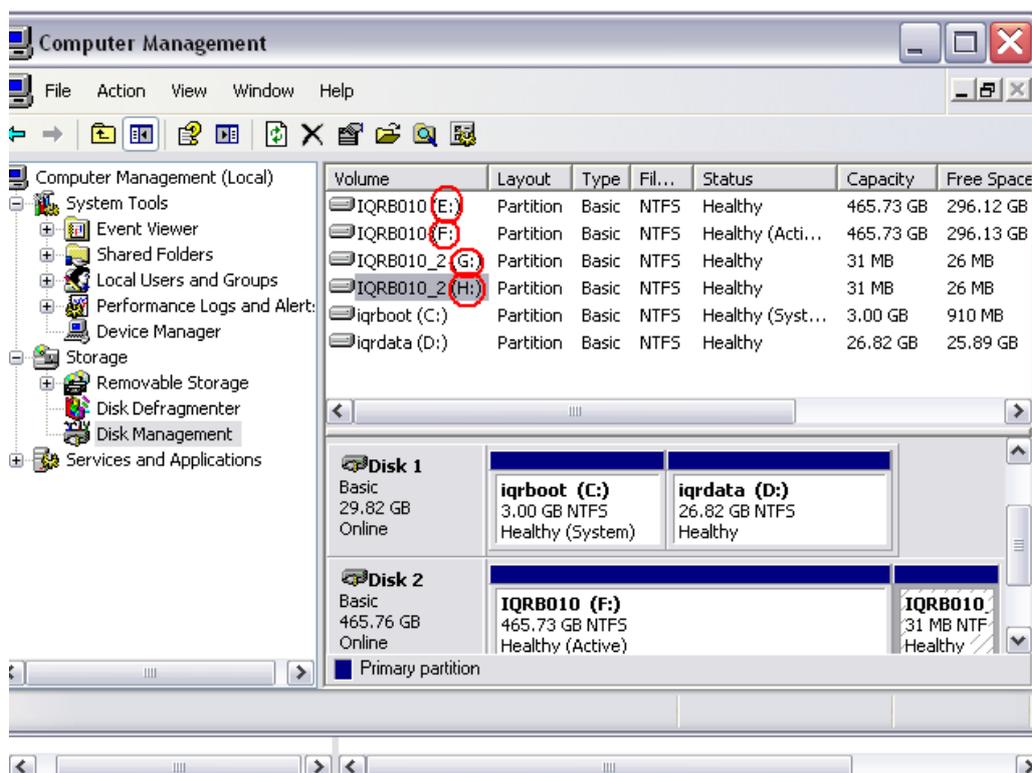
figure 2 : correct driver letter assignment

If a new disk option is installed in an IQR, it may happen that the drive letter assignment by Windows is not executed properly. The IQR then can't find the disk option correctly and the firmware can't load files.

Drive letters "E" and "G" must be on Disk 0, "F" and "H" must be on Disk 2.

To fix this error, use the windows disk management tools. Execute the following steps :
