R&S®NRP-Z81/-Z85/-Z86

Wideband Power Sensor

Release Notes

Firmware Version 01.37

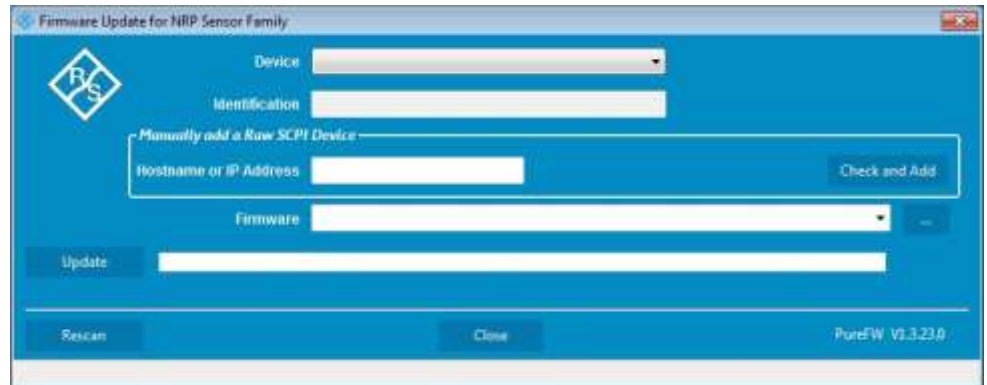
1. Start the Firmware Update program via "Start menu > NRP-Toolkit > Firmware Update". The following window should appear:

The program automatically starts scanning for R&S NRP-Zxx power sensors. When the scan is completed, all recognized power sensors are listed in the "Device" dropdown control.

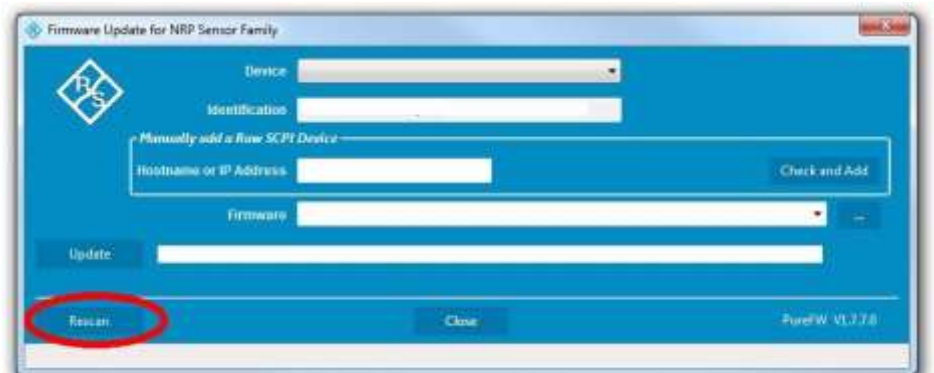
If the sensor you want to update is not listed in the "Device" dropdown control, press "Rescan" to search for attached sensors.

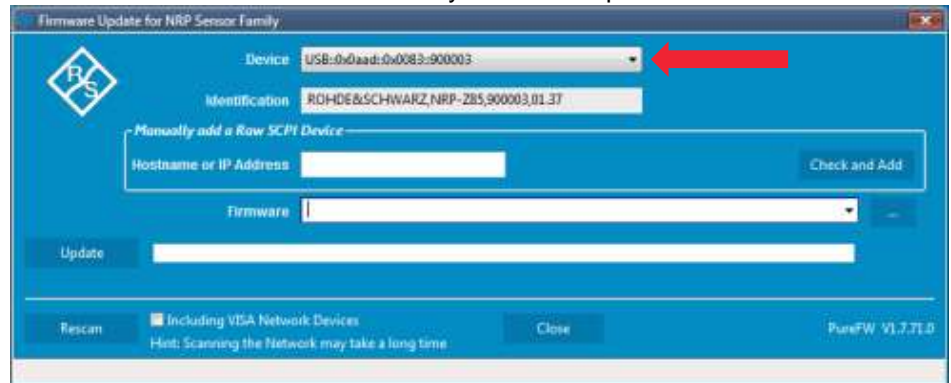
3. In the "Device" line select the sensor you want to update.

The "Hostname or IP Address" field is not used during this procedure and should therefore be left empty.

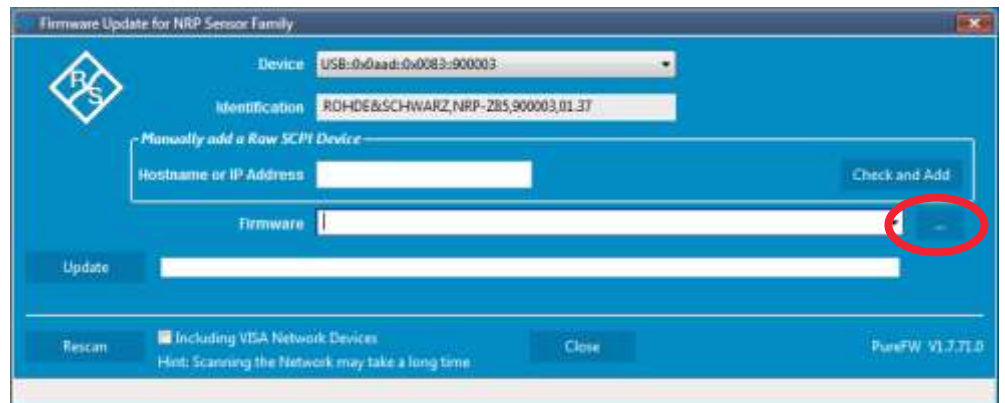
4. In the "Firmware" field enter the full path and file name of the update file or press the ellipsis button to browse the file system for it. New firmware for the R&S NRP-Zxx power sensors generally has an *.nrp extension.

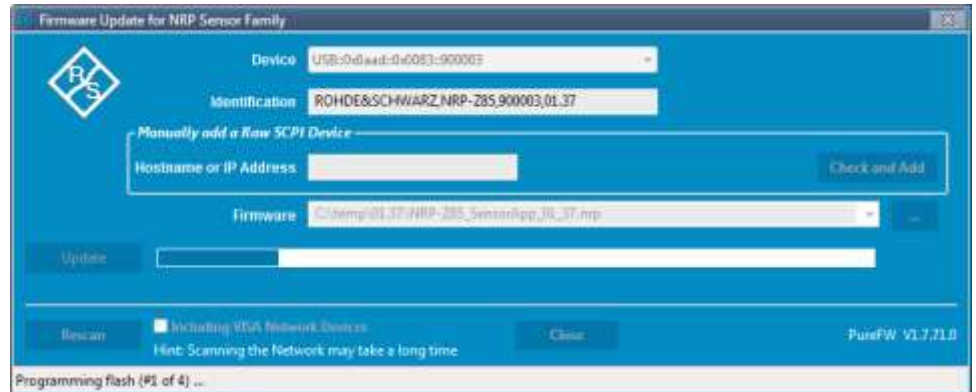
- Click on the "Update" button to download the new firmware and program it into the flash memory of the sensor.

During the update process the progress is shown through a progress bar. The update sequence may take a couple of minutes, depending on the sensor model and the size of the selected file.

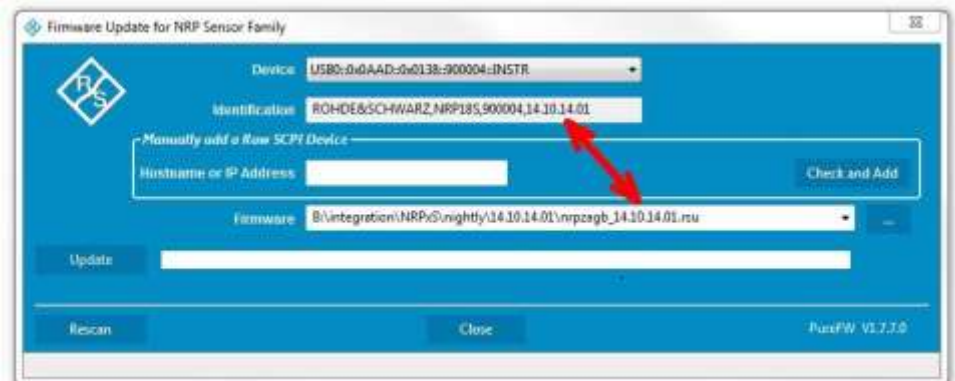
- Check if the update was successful. This is the case if the firmware version in the "Identification" field is the same as the one you loaded in the "Firmware" field.
