# R&S® SLG

## Satellite Load Generator

### Release Notes

### Firmware Version 01.10

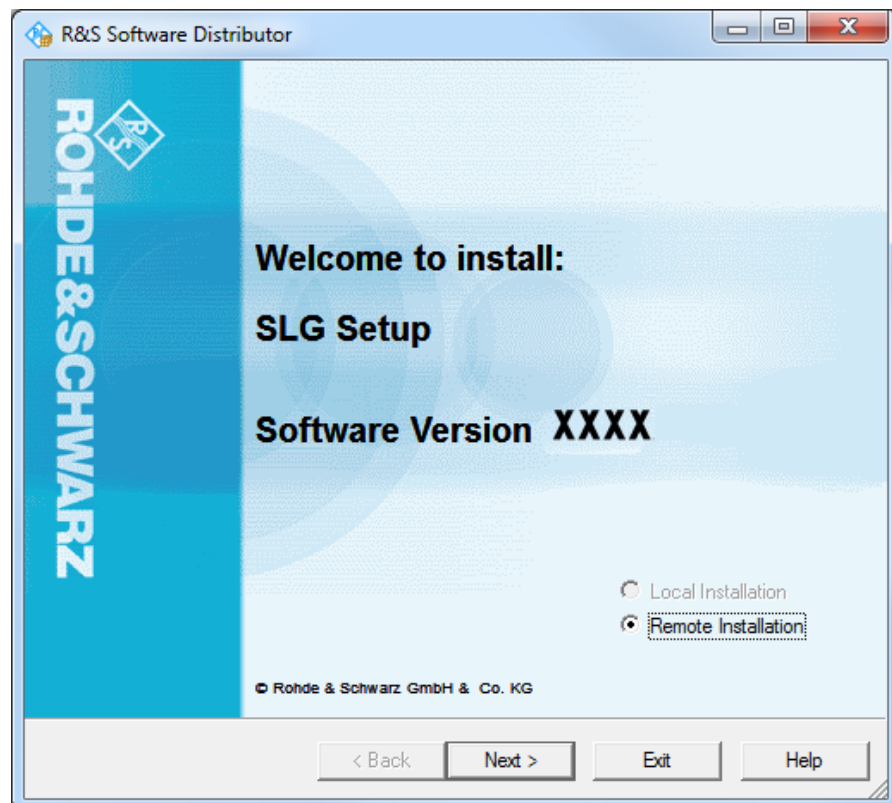
1. Make sure that the computer and the R&S SLG are connected by LAN.
2. Switch on the R&S SLG.
3. Wait until the R&S SLG firmware has booted and the application has started.
4. On the computer, execute *SLG\_Setup\_FW\_xxxx.exe*.  
The "R&S Software Distributor" is displayed. Only "Remote Installation" is available.

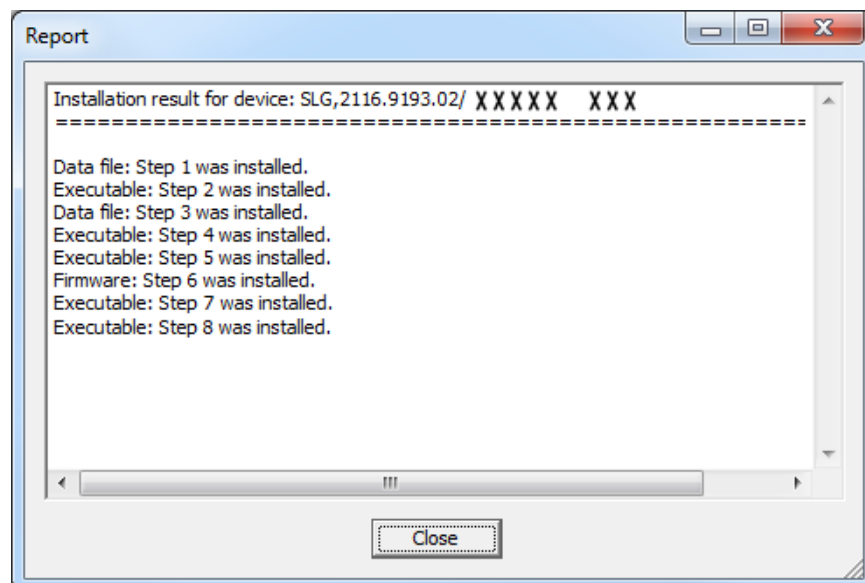
- Click "Report" to view the installation report. If the installation was successful, no errors are displayed (see example below).
