ROHDE & SCHWARZ

Release Notes

Firmware Release 4.73 SP5

for R&S ESU EMI Test Receiver

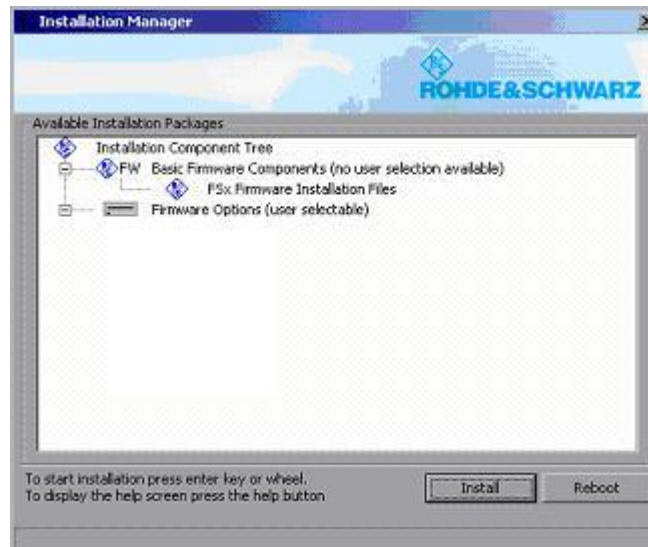
The *Installation Manager* will terminate the analyzer application, search for available application update set and will show a selection list.

- Start the installation process with INSTALL. REBOOT will abort the update and restart the analyzer application without any changes.
- The instrument will perform several automatic shutdowns, until the new firmware is installed properly.
