R&S®EPL

Release Notes

Firmware Version 1.20

These Release Notes are for following models of the R&S®EPL Measurement Receivers:
R&S® EPL1000, order no. 1350.4444K10

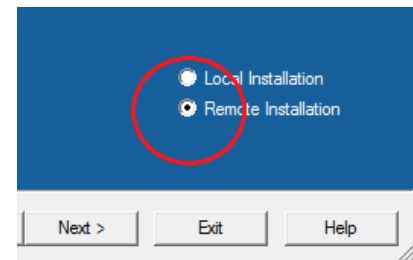
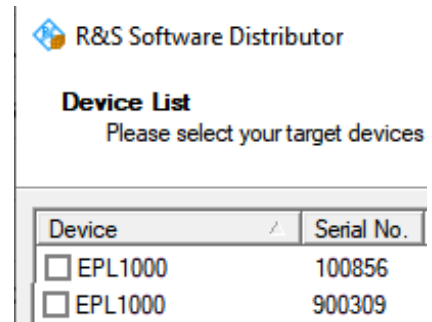
6. The setup procedure scans your LAN subnet and displays all found instruments
7. Select the instruments you want to update. You can select up to 5 instruments to update in parallel.

FOR FIREWALL USERS: The EPL1000Setup.exe communicates with the instrument via LAN. Therefore, the EPL1000Setup.exe file must pass the firewall. Add it to the firewall rules, then restart the scan using "Rescan".
