R&S®CLGD

DOCSIS Cable Load Generator

Release Notes

Firmware Version 1.4.5

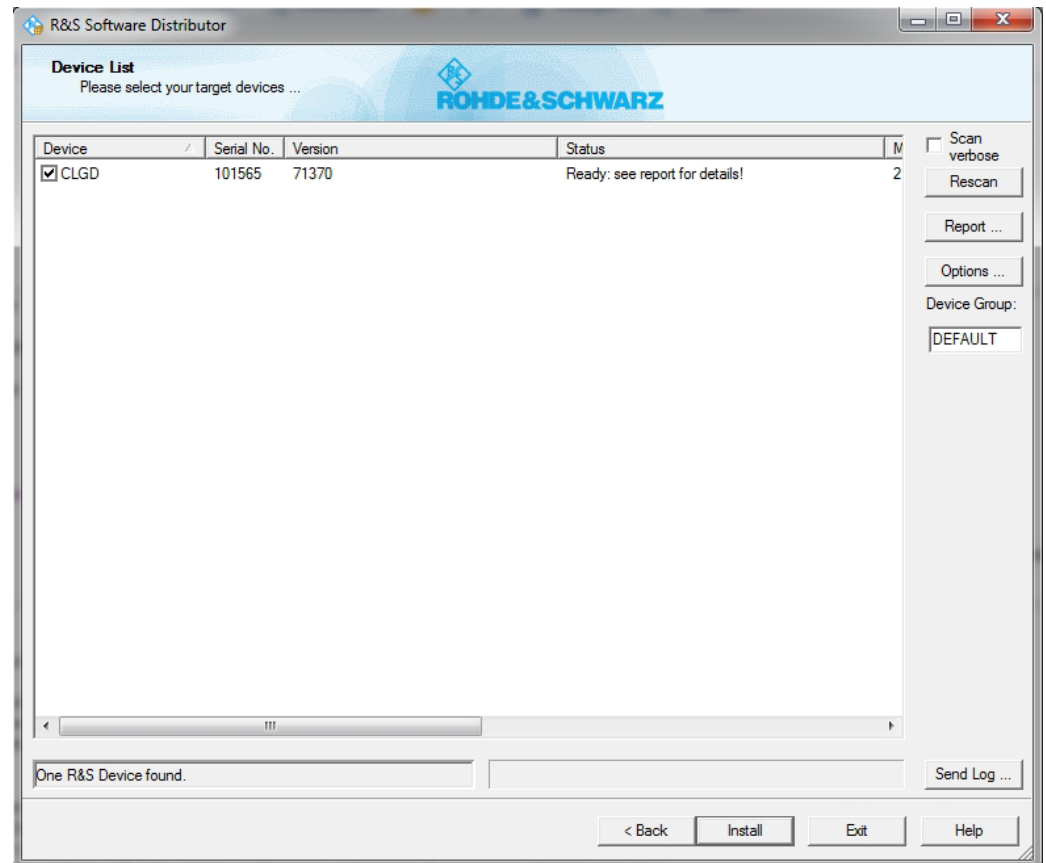
9. Click "Install".
The installation process itself is self-explanatory and may take up to 10 minutes.
After the installation, the "Status" is changed to "Ready".

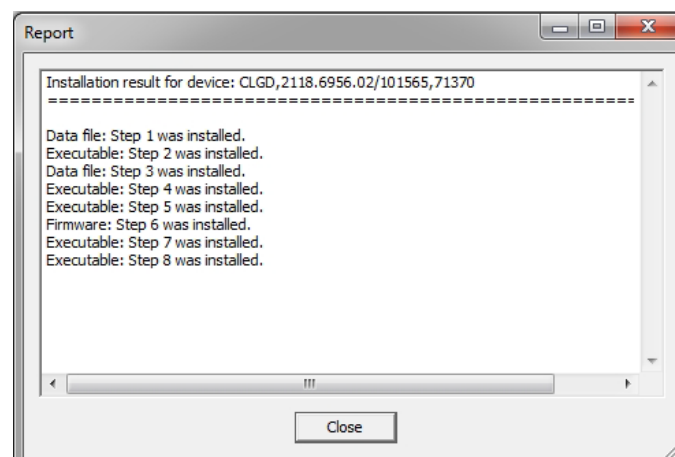
10. Click "Report" to view the installation report. If the installation was successful, no errors are displayed (see example below).
